**ANIMAL VEHICLE CRASH
MITIGATION USING
ADVANCED TECHNOLOGY
PHASE I: REVIEW, DESIGN AND
IMPLEMENTATION**

Final Report

SPR-3(076)

August 2006

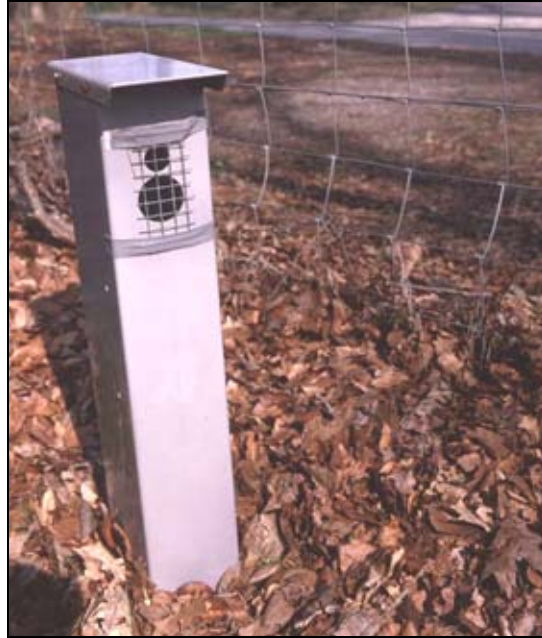
Figure 4.10: Cabinet with infrared sensor in Ugchelen, The Netherlands.
The wire in front of the two openings prevents birds from nesting in the box. (Photo: Marcel Huijser/WTI-MSU).

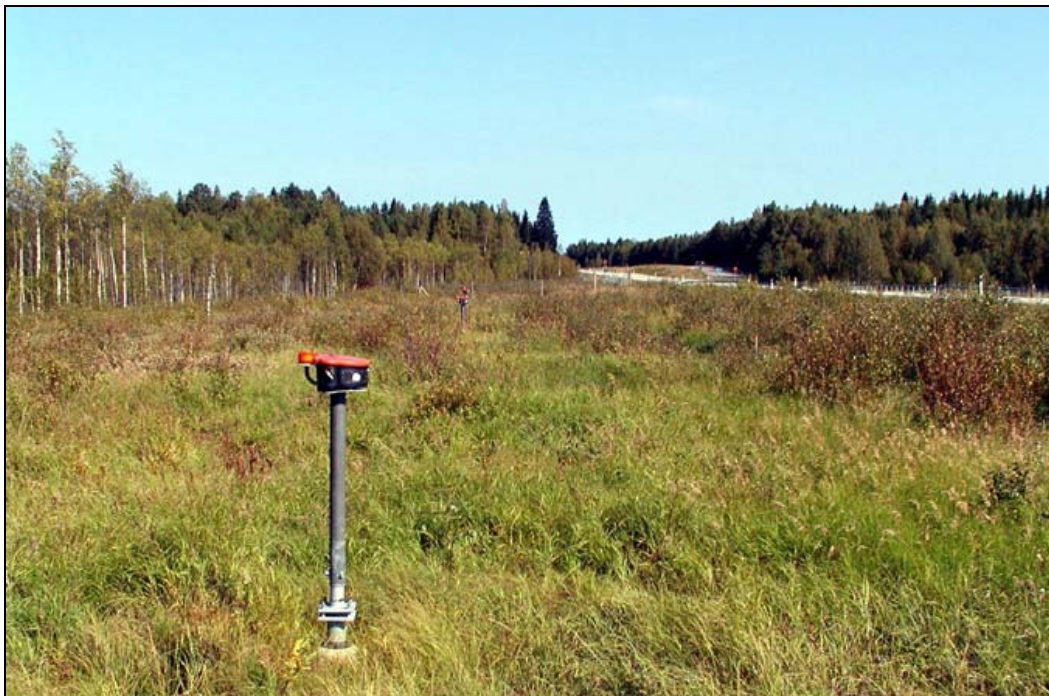
Figure 4.12: The posts holding the lights in Rosvik, Sweden (Photo: Andreas Seiler).

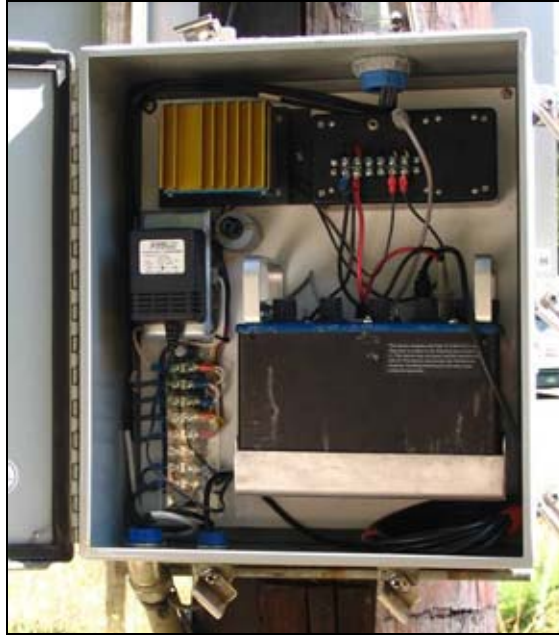
Figure 4.25: Cabinet with electronics for automated scanning for frequencies of radio collared elk and battery at one of the receiver stations in Sequim, Washington, USA (Photo: Marcel Huijser, WTI-MSU)

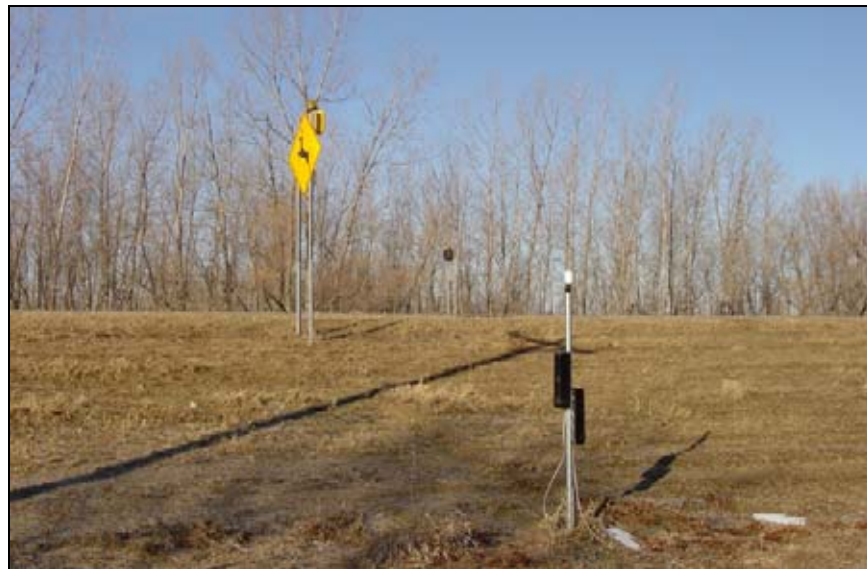
Figure 4.27: The sensors in the right-of-way in Marshall, Minnesota, USA (Photo: Robert Weinholzer, MNDOT)

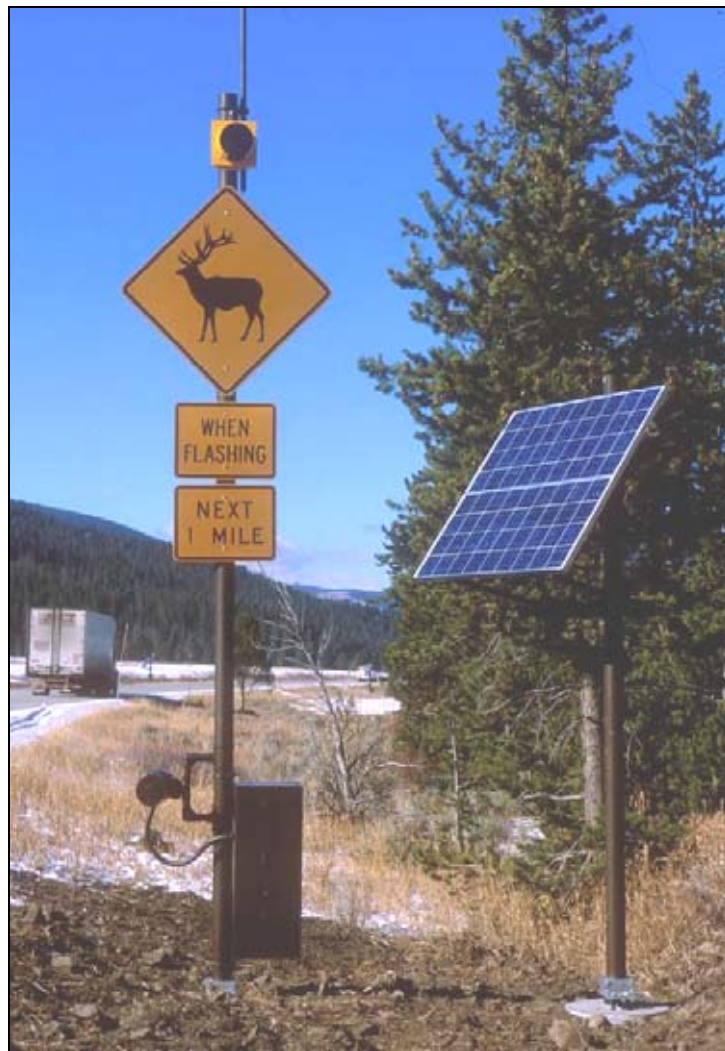
Figure 4.36: Original warning signal and sign in Yellowstone National Park, Montana, USA. A sensor is attached on the left side of the post; a cabinet with circuit boards and batteries is attached to the right side of the post. (Photo: Marcel Huijser, WTI-MSU)

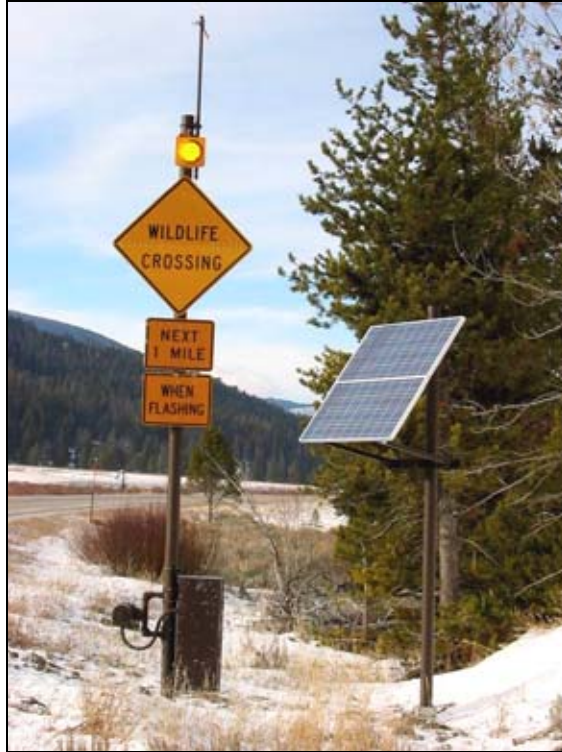
Figure 4.37: Activated warning signal and sign with new text sign “WILDLIFE CROSSING” and solar panel in Yellowstone National Park, Montana, USA (Photo: Marcel Huijser, WTI-MSU)

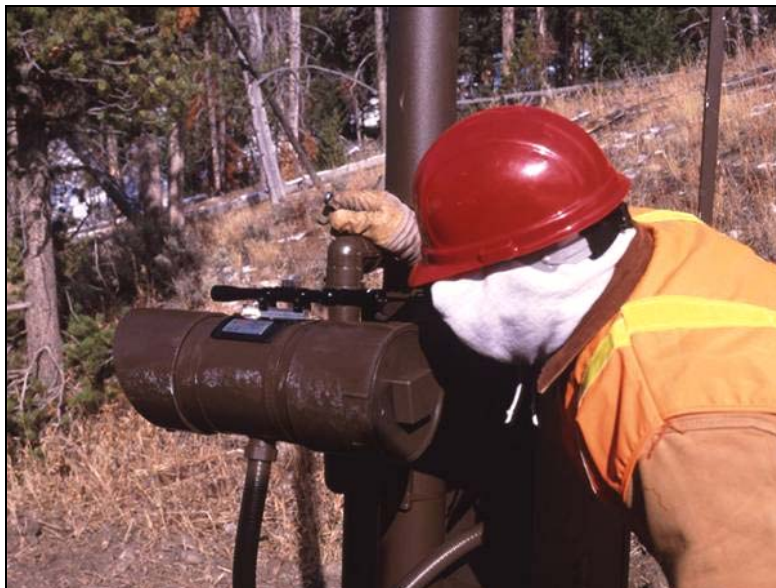
Figure 5.24: Sensors at the MT site were aligned by usnig a scope (Photo: Marcel Huijser, WTI-MSU)

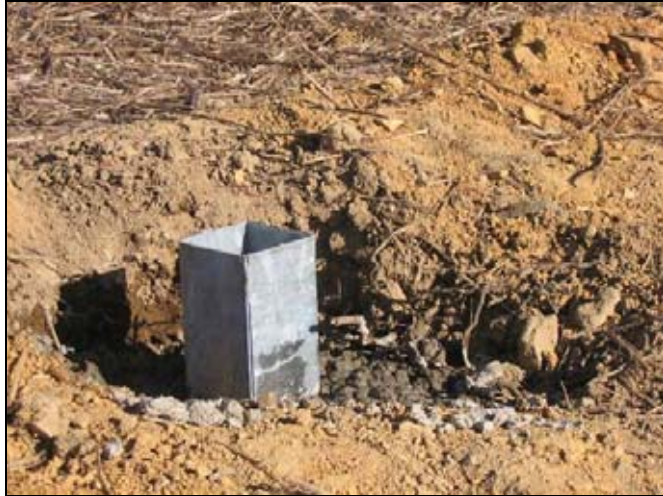
Figure 5.26: The wooden poles were fitted with a concrete foundation at the PA site (Photo: Marcel Huijser, WTI-MSU)

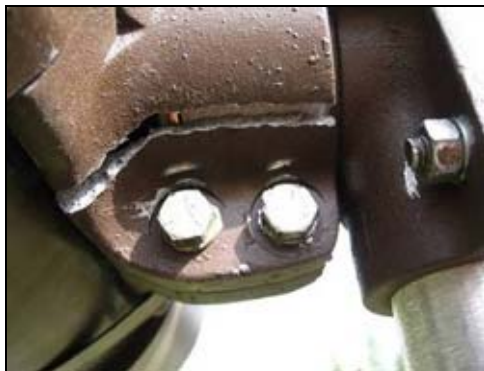
Figure 6.8: The brackets holding the sensors cracked as a result of extreme temperature fluctuations at the MT site
(Photo: Marcel Huijser, WTI-MSU)

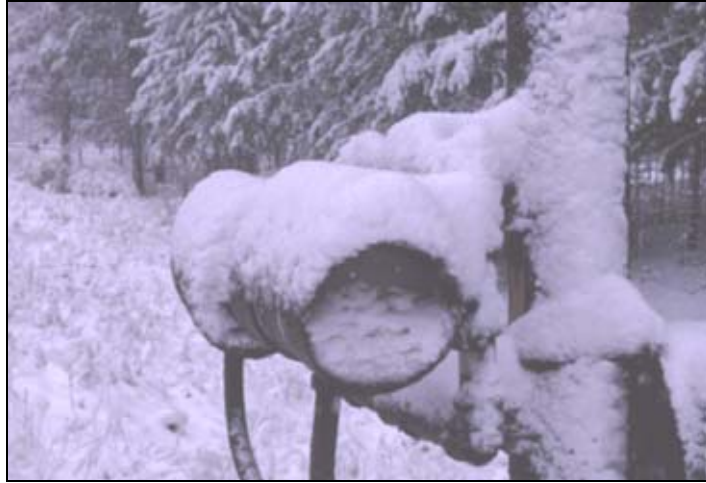
Figure 6.9: Snow and ice build-up on the sensors caused false positives at the MT site (Photo: Marcel Huijser, WTI-MSU)

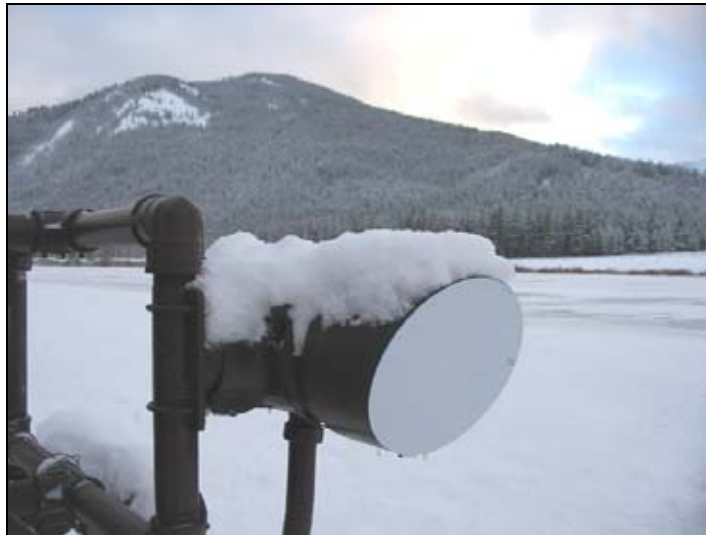
Figure 6.10: Placing a smooth surface at an angle in front of the sensors prevented snow and ice build-up on the sensors at the MT site (Photo: Marcel Huijser, WTI-MSU)

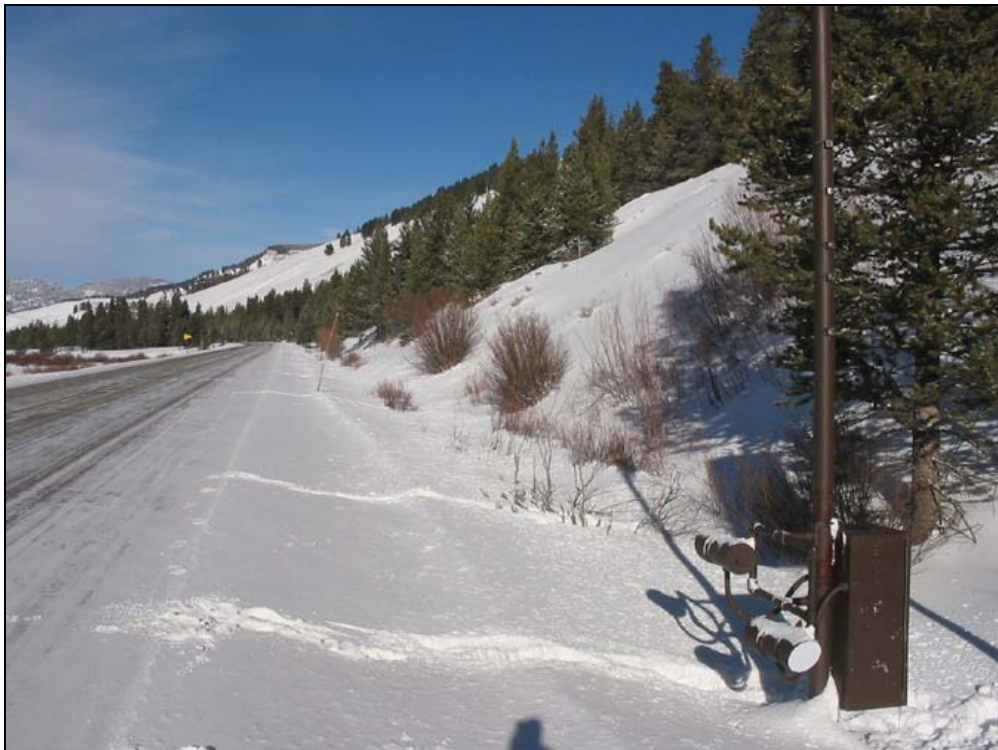
Figure 7.6: Investigation for potential blind spots. The tracks indicate where human models passed through the beam. (Photo: Marcel Huijser, WTI-MSU)

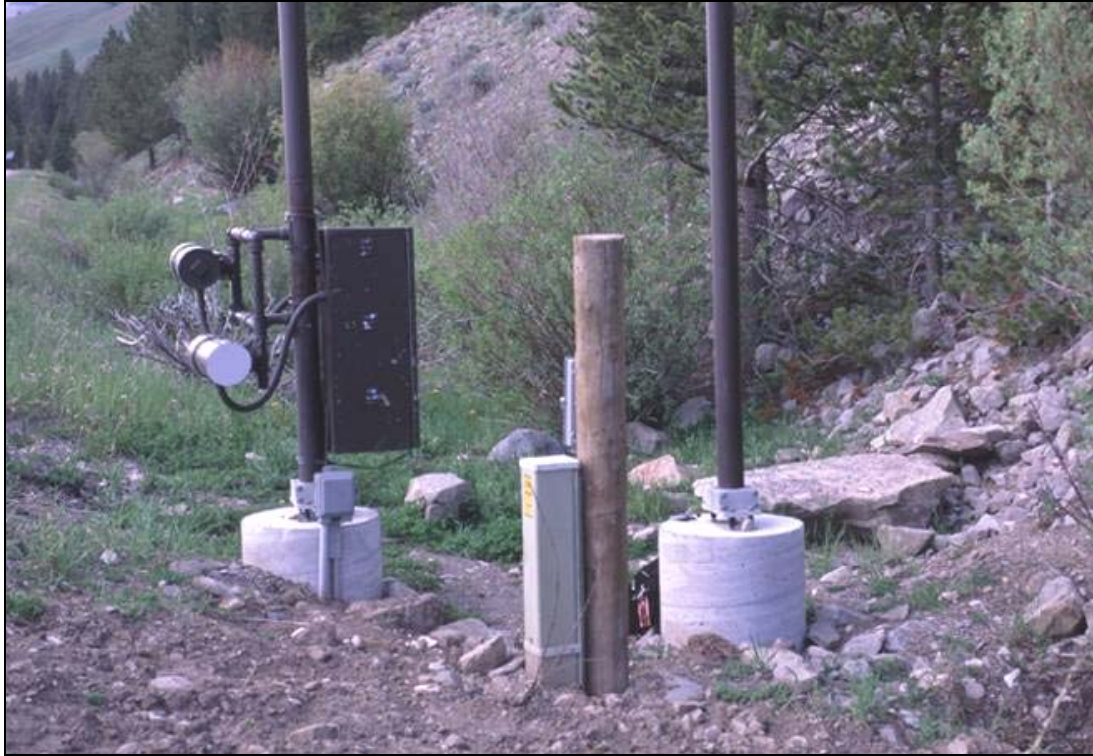
Figure 8.1: Some of the concrete foundations were in the clear zone and too high above the ground. This is the master station. The wooden post on the foreground is for the link to the land-based phone line. (Photo: Marcel Huijser, WTI-MSU)

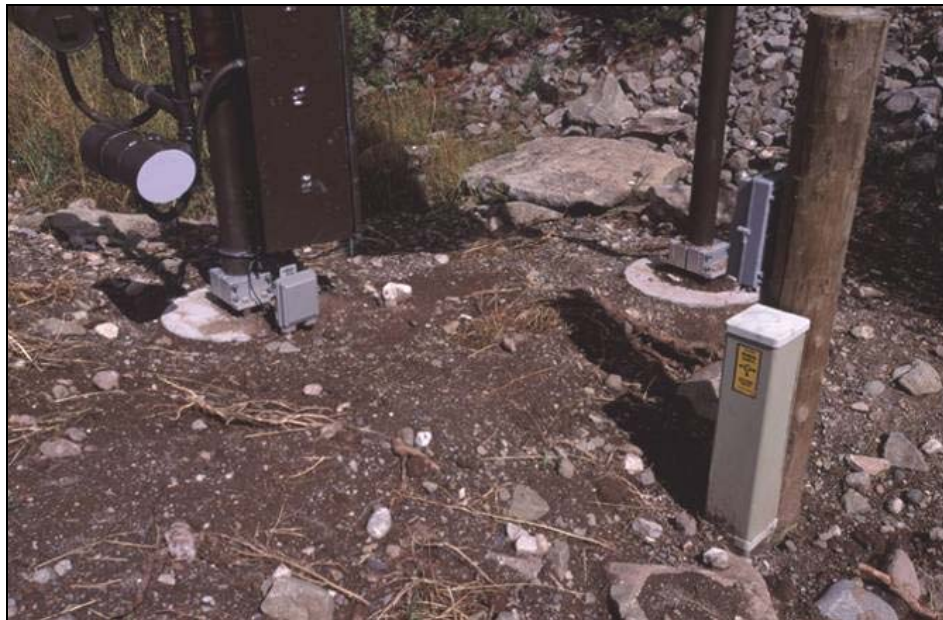
Figure 8.2: The problem with some of the concrete foundations was addressed by putting weed free soil around the posts while not blocking the drainage from the road. (Photo: Marcel Huijser, WTI-MSU)

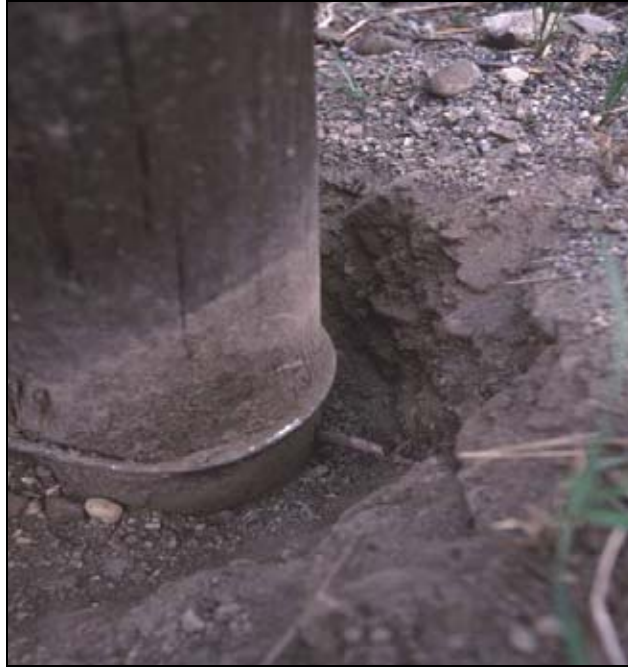
Figure 8.3: Some of the wooden poles were buried too deep. The stick indicates the upper of the three holes that serve as a break-away in case of a collision. All three holes should have been above the ground level. (Photo: Marcel Huijser, WTI-MSU)

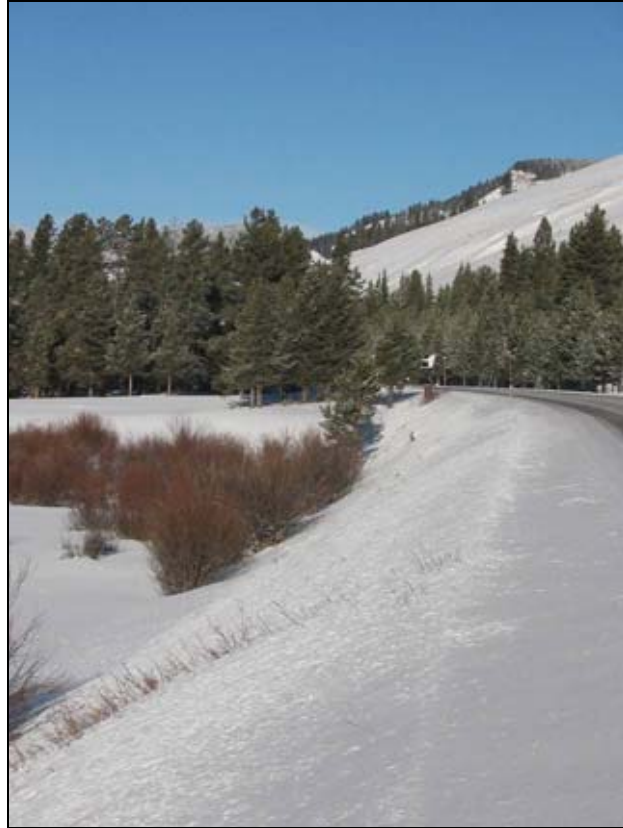
Figure 8.5: Curves and slopes caused the beam to shoot too high in some locations at the MT site, causing blind spots. Shown here is detection Zone 8 (see Figure 5.7 for exact location). (Photo: Marcel Huijser, WTI-MSU)

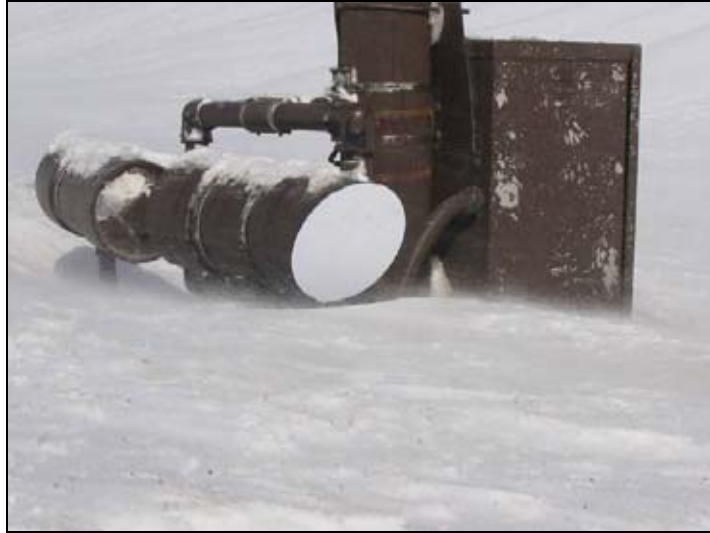
Figure 8.6: Snow accumulation at the MT site. Snow accumulation may bury the sensors, potentially causing downtime for the system. (Photo: Marcel Huijser, WTI-MSU)

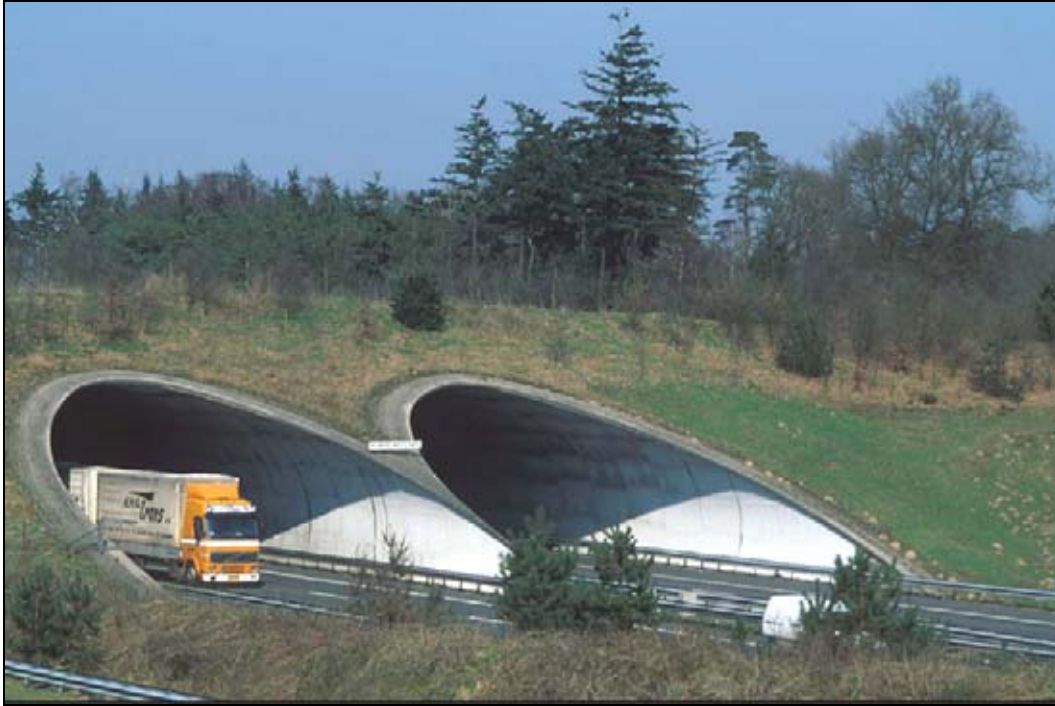
Figure 10.2: Wildlife crossing structures are often combined with wildlife fencing to guide the animals towards the crossing structure. Since some animals may walk the other way and cross the road where the fence ends, an animal detection system may be applied also. (Photo: Marcel Huijser, WTI-MSU)

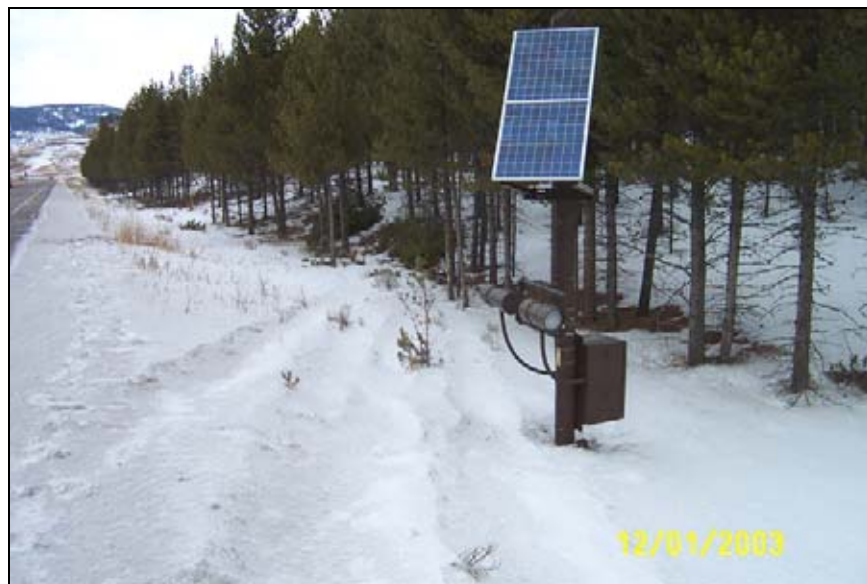
Figure 10.3: Animal detections may reduce or prevent animal-vehicle collisions, but the poles and equipment in the right-of-way form a hazard of their own. Here a car went off the road at the MT site and just missed the pole. However, the damage to one of the sensors was about \$2000. (Photo: Jason Norman, MDT)
